***Challenges of Field Application of Plural
Component, Thick-Film Coatings and Linings;
Interior and Geotextile Applications***

**Dudley J Primeaux II, PCS
Lee Bower**

**PACE 2008 "The Power of Paint + Coatings"
January 27 – 30, 2008
LA Convention Center - Los Angeles, CA**

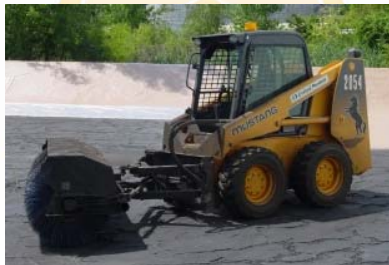
- SSPC-SP 3, Power Tool Cleaning
- “Bobcat” fitted with power-roller brush
- Removed loose gravel, knocked down asphalt heave
- Geotextile covered the asphalt substrate

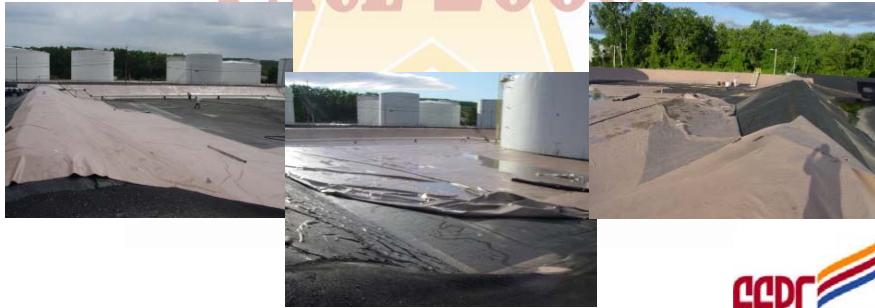
- **The Mighty Wind!**
 - Lifted a previously applied section
 - Poor termination technique

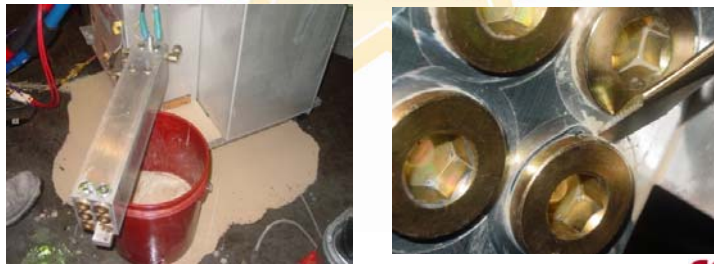
- **Project #1**
 - Blown resin heater plugs, factory equipment issue
 - Off-ratio application, clean-up
 - Proper training prevented application problems

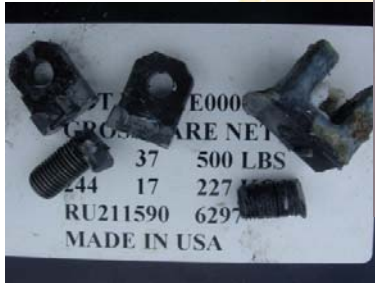
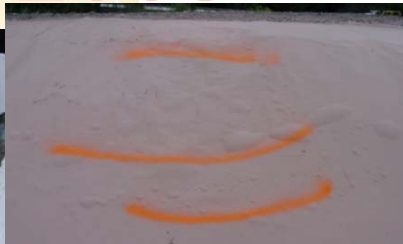
- Broken Clevis', proportioner
- Off-ratio application of material, re-spray / repair
- Prepared, had replacement parts!

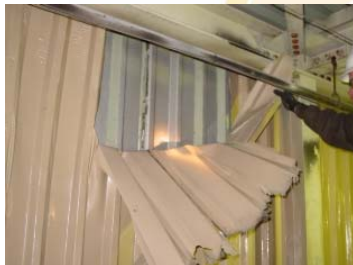
- Complete delamination of wall area
- Substrate temperature **not** above dew point
- Thin sheet of ice present (invisible)
- Remove, prep & re-spray

- What is the required substrate temperature to dew point temperature difference?
- Substrate **MUST** be 5°F (3°C) above, and rising, the dew point temperature!
- Moisture and / or ice on substrate will inhibit bonding of polyurea

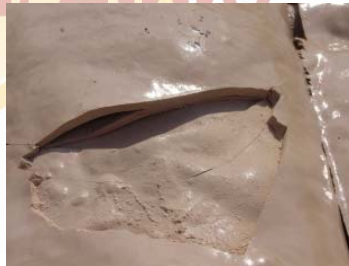
- Foaming of applied polyurea
- Water in Resin drums, loose bungs & rain
- Infamous “purple” liquid
- Cut-out and repair

- Eventhough a **Polyurea**, if you put / get water in the system, it may react and cause issues.....
