## **Application Profile**

Project:	NISSAN Motor Manufacturing Corp, Canton, MS
<b>Project Contractor:</b>	Malouf Construction Corporation Mansfield Industrial, Kenny Industrial Services Company
Polyurea Applicator:	Fast Set Coatings, Inc., Austin, Texas Inspection / Project Monitoring by Primeaux Associates LLC
Polyurea System Applied:	WARRIOR <sup>tm</sup> 240, Visuron Technologies, Inc. Chemical Containment Systems, Inc. / V-tac Group
Substrate / Area:	Concrete Wastewater Tank / Pump Room, approx 7,000 ft <sup>2</sup>

## Date: August, 2002

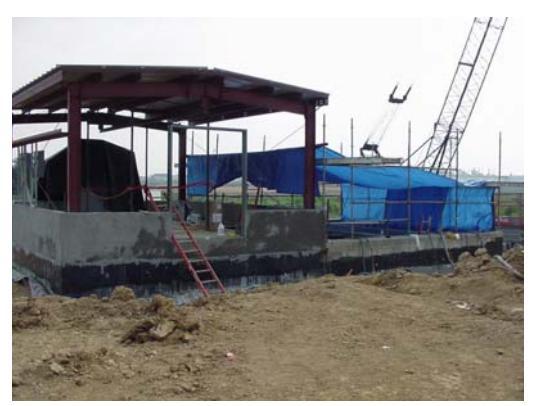
NISSAN is building a new assembly plant in Canton, MS. Part of the plant required their own waste water treating facility. In order to protect the concrete CIP pits and pump room floor from this highly corrosive environment, WARRIOR 240 polyurea system was chosen over a conventional polyurea spray elastomer system. The prepared concrete surface was to first receive 8 to 10 mils of the Pronto-Prime (2-part urethane) priming system followed by 80 mils of the WARRIOR 240 polyurea system.

The specification called for abrasive blasting of the Cast-In-Place concrete structure followed by a re-surfacer to fill opened bugholes. Unfortunately, a re-surfacing material had not been applied and the WARRIOR 240 system had to be installed at a much higher film thickness over the ProntoPrime priming system in order to complete filling of the minor bugholes. The narrow size of the 40 foot deep processing pits also presented a challenge for spray application. Scissor lifts were inserted into the larger of the pits while a Spider Lift was used for access in the smaller pits.

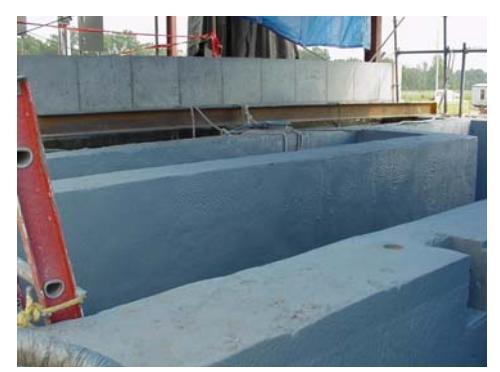
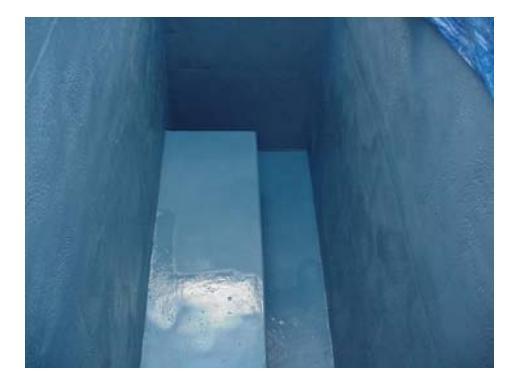
The WARRIOR 240 system was applied at an average film thickness of 100 to 120 mils. Within the same day of applying the WARRIOR 240 system, several large mechanical pieces of equipment where installed in the pits. This caused some damage to the applied coating, which was then easy treated and repaired using the WARRIOR 240 spray system. The application was completed in a timely manner and will give excellent service and corrosion protection for the concrete. The pump roof floor was installed with a stipple / non-skid texture.
