Application Profile

Project: First Baptist Church; Building Annex Roof

Polyurea Applicator: Primeaux Associates LLC

Polyurea System Applied: VersaFlex SL 75; Low Pressure Spray Process

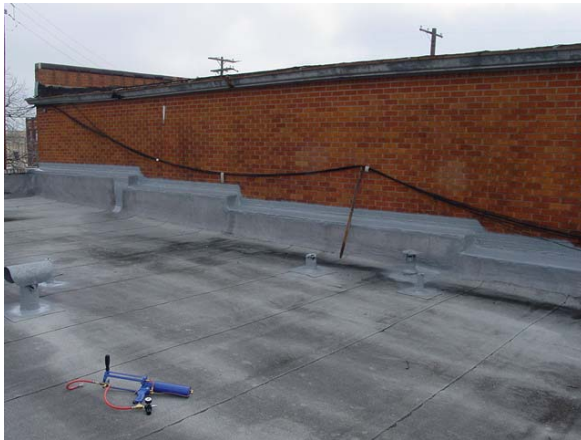
The First Baptist Church in Elgin, Texas purchased a next door building for use in Sunday School and other events. The problem was that the building was constructed next to an original building and the common wall at the top of

at the parapet roof line was leaking during rains into the building. Leakage was also occurring at the vent tube penetration through the flat roof deck. Due to the relatively small size of the area, the use of conventional spray application / equipment would have been financially prohibitive. As it was felt that the use of the polyurea technology was the best solution for repair and sealing the area, it was decided that the VersaFlex SL 75 joint sealant system would be used and applied via cartridge tubes / low pressure spray.

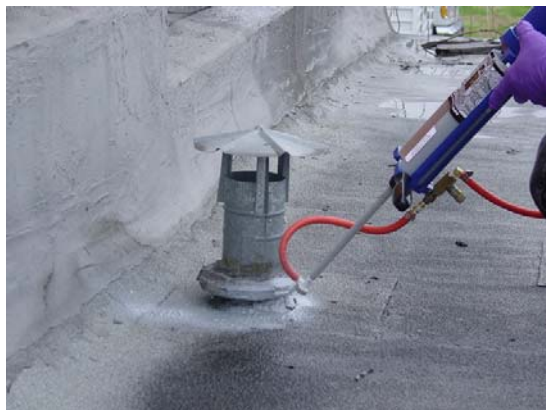
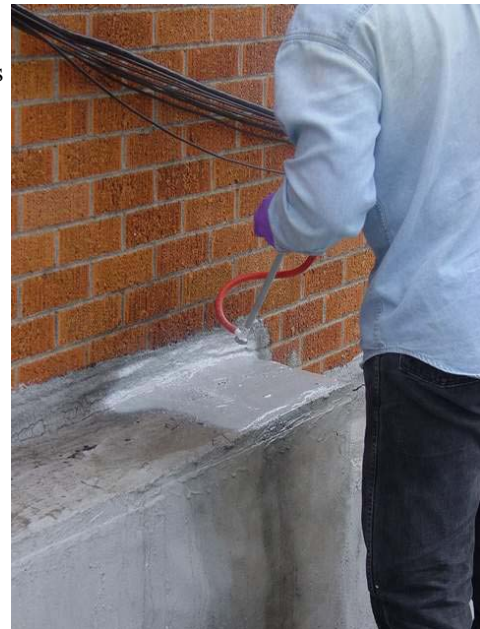
The SL 75 was applied to the top edge of the parapet roof wall and onto the wall of the brick building at a film thickness of average 50 mils. Cracking and erosion of the original applied asphalt type system was noted and the source of the leakage. The SL 75 was also applied around the vent stack penetrations in the flat roof area. The SL 75 was applied via dual 300 X 300 ml cartridges, through a static mix tube with an air atomization cap for a spray pattern / dispense. The material was processed using a pneumatic cartridge gun at 90 psi air.
